DEPARTMENT OF TRANSPORTATION

Quality Assurance and Source Inspection

Contract #: 04-0120F4Cty: SF/ALA Rte: 80 PM: 13.2/13.9File #: 69.28**WELDING INSPECTION REPORT****Resident Engineer:**Siegenthaler, Peter**Address:** 333 Burma Road**City:** Oakland, CA 94607**Report No:** WIR-023079**Date Inspected:** 27-Mar-2011**Project Name:** SAS Superstructure**OSM Arrival Time:** 1500**Prime Contractor:** American Bridge/Fluor Enterprises, a JV**OSM Departure Time:** 300**Contractor:** Zhenhua Port Machinery Company, Ltd (ZPMC), Changxing Island **Location:** Shanghai, China**CWI Name:** Mr. Li Yan Hua**CWI Present:** Yes No**Inspected CWI report:** Yes No N/A**Rod Oven in Use:** Yes No N/A**Electrode to specification:** Yes No N/A**Weld Procedures Followed:** Yes No N/A**Qualified Welders:** Yes No N/A**Verified Joint Fit-up:** Yes No N/A**Approved Drawings:** Yes No N/A**Approved WPS:** Yes No N/A**Delayed / Cancelled:** Yes No N/A**Bridge No:** 34-0006**Component:** OBG**Summary of Items Observed:**

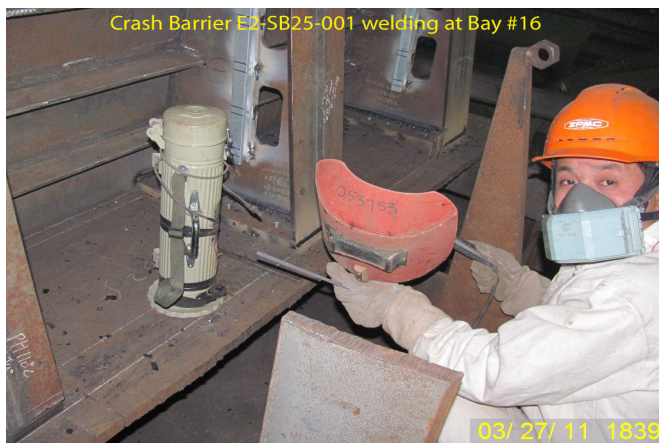
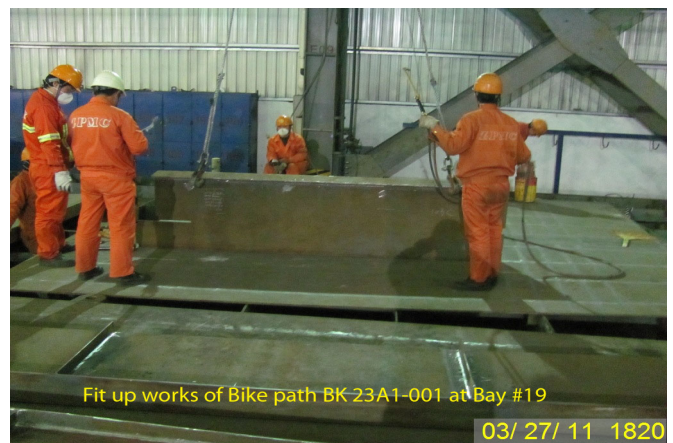
Weld joint- 030, 031 Located on Crash Barrier E2-SB26-001. Welder is identified as 222396. ZPMC Quality Control Inspector (QC) is identified as Ma Qian Li. The welding variables recorded by QC appeared to comply with the WPS-B-T-2132-Esab.

Weld joint- 065, Located on Suspender Bracket SB28-001-110W. Welder is identified as 259566. ZPMC Quality Control Inspector (QC) is identified as Li Peng. The welding variables recorded by QC appeared to comply with the WPS-B-P-2213.

For further information see below pictures:-
